Re: Final Report, Geotechnical Evaluation of Landslide Near SR-3 and Gorst Creek
Gorst, Washington

April 22, 1997
HWA Project No. 97063

Subject: **Geotechnical Evaluation**
Gorst Creek Landslide
SR-3 at Gorst Creek
Gorst, Washington

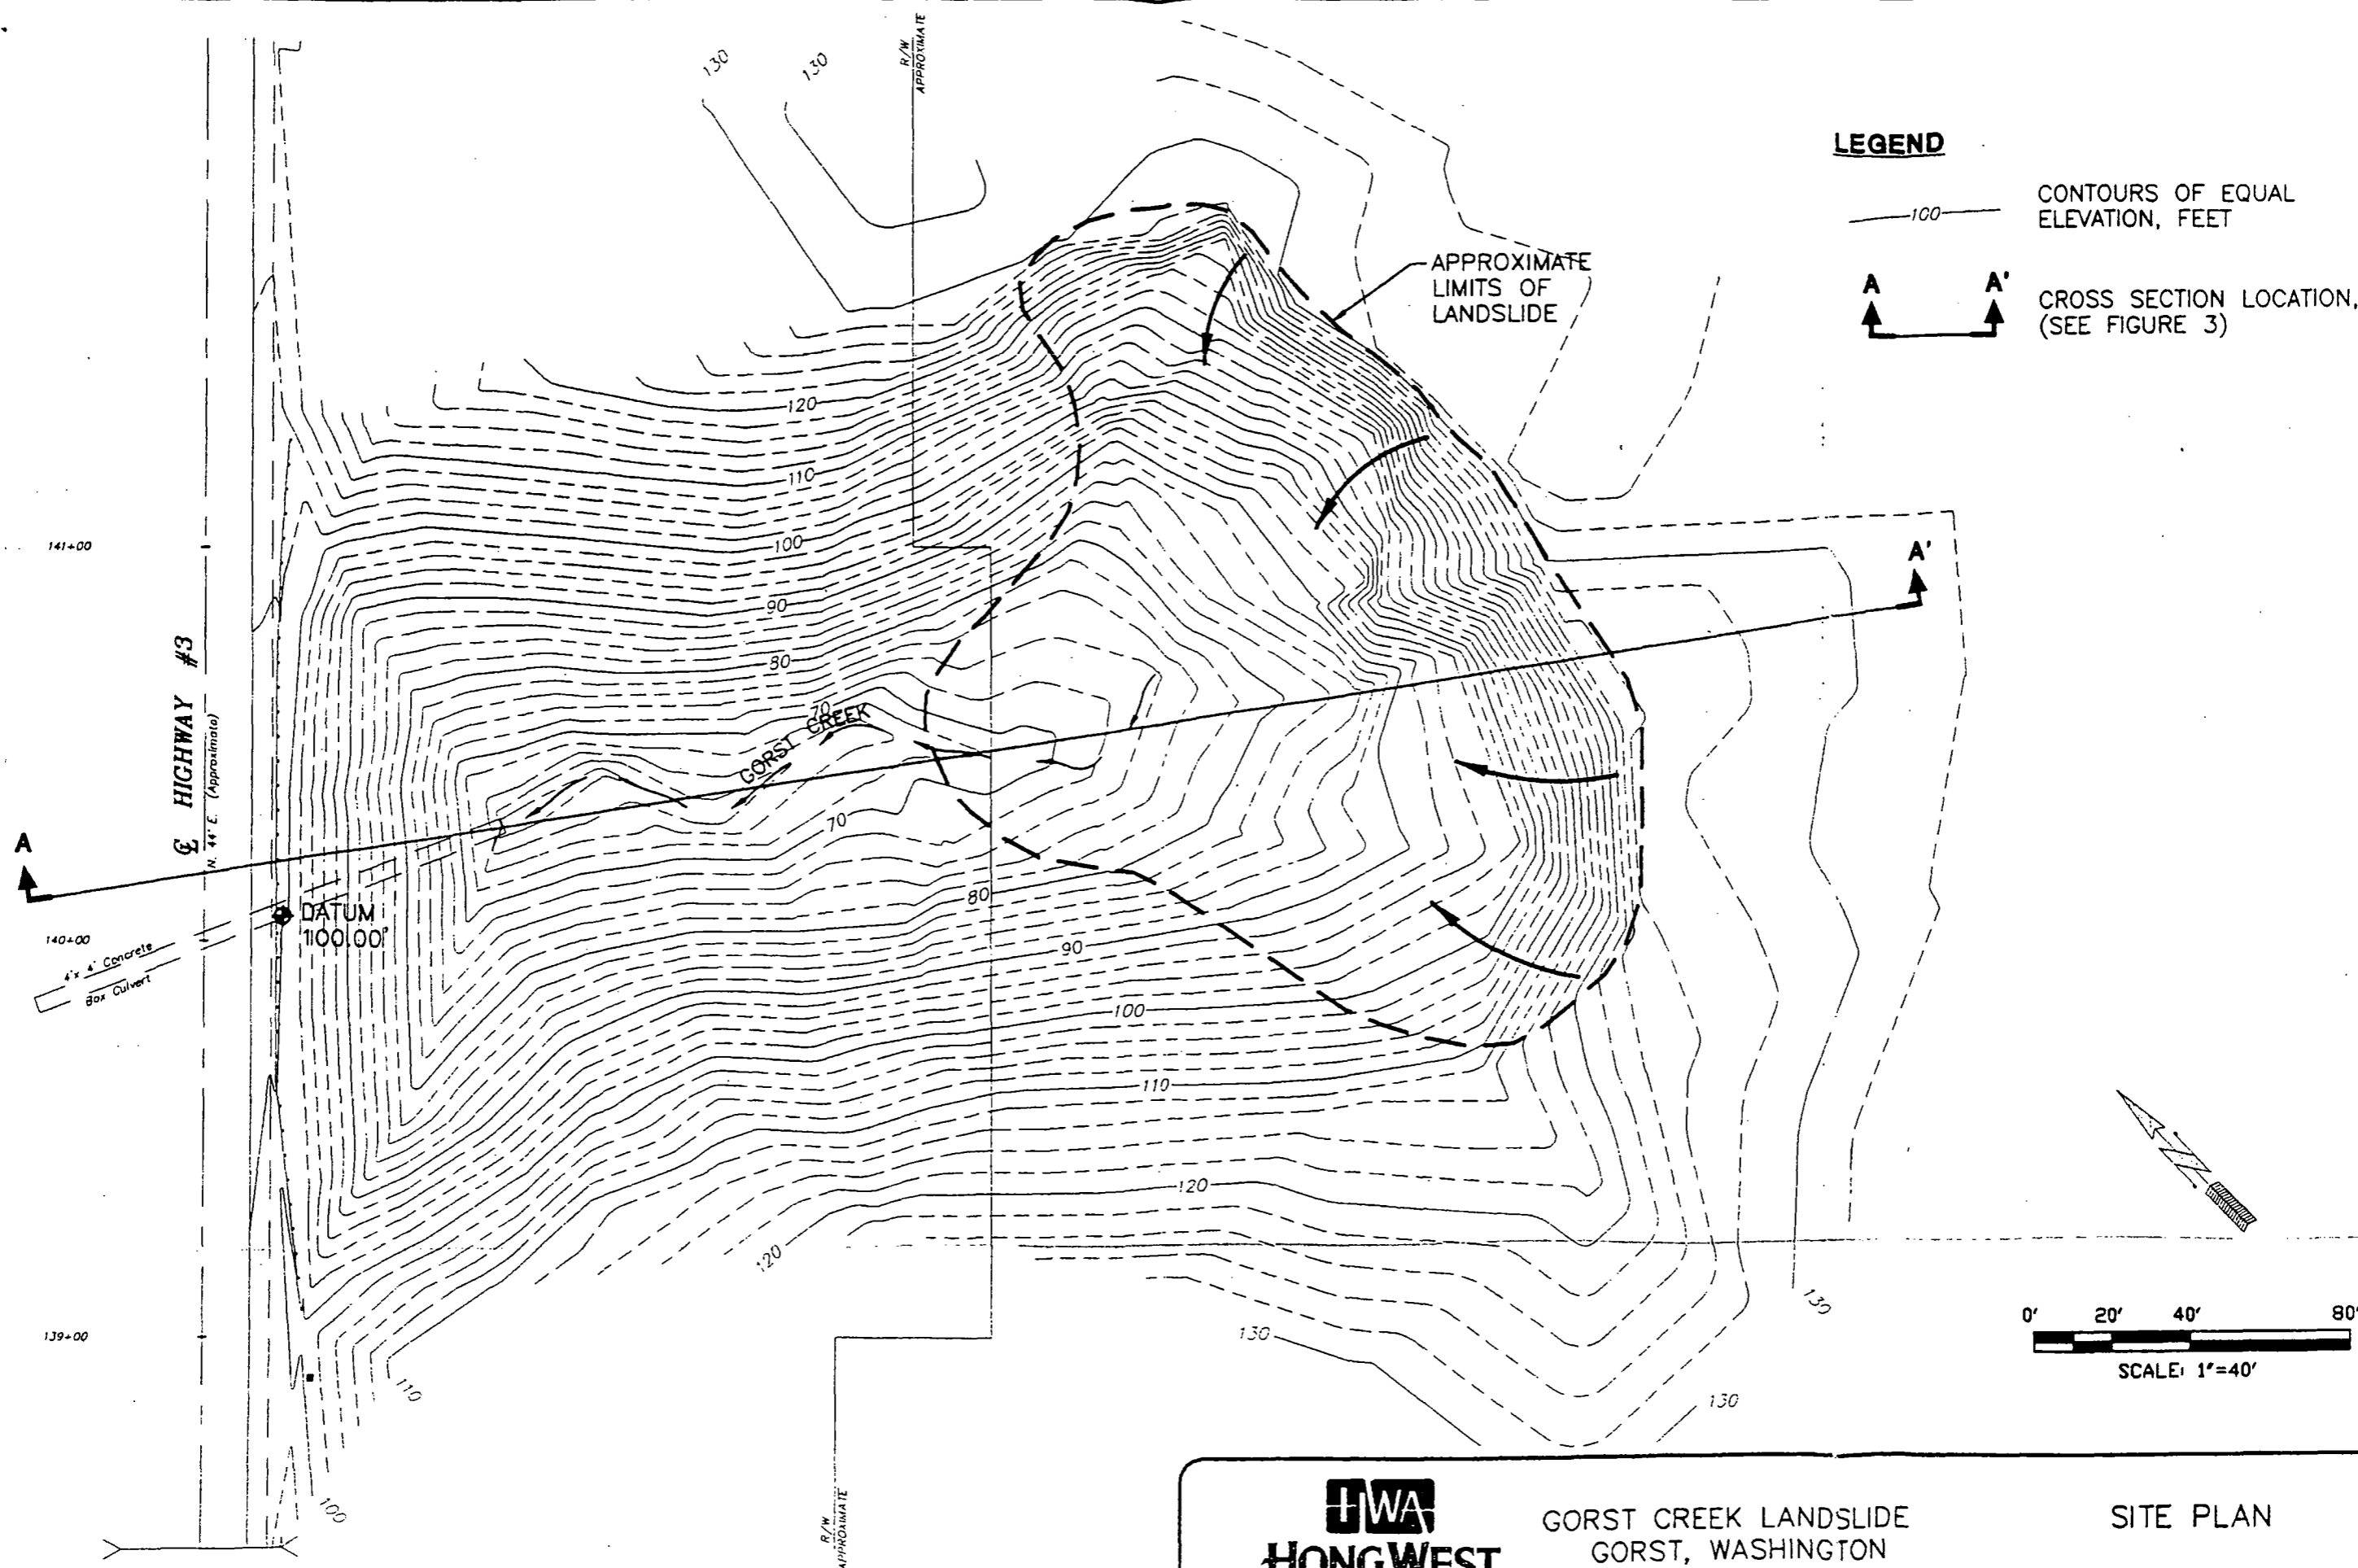
SITE PLAN

The landslide consists of a steep scarp, approximately 20 feet in height, with debris (garbage) deposited on the lower slope as shown on Figures 2 and 3. The scarp exposes garbage from the landfill, while the lower portion of the slide is garbage debris mixed with sands and gravels.

During our site visit, water was seeping from the base of the slope in several locations. Seepage likely originates from the permeable soils near the base of the landfill and/or from the buried culvert. It is possible that the culvert is partially or completely blocked, with stream flows finding an alternate path under the landfill.

Erosional gullies were noted at the top of the landfill. The high flows in the creek bed during the storm were likely a combination of overland flow down the slope, stream flow under the landfill, and seepage from the slope face.

Although no apparent signs of continued slope movement were noted during our reconnaissance, additional slope failures could occur. If future sliding occurs, it will likely be sloughing of the upper portion of the landslide scarp; however, future large-scale events cannot be ruled out. Even without slope failure, continued transport of sediment and debris downstream is likely during heavy rainfall events.

- The upstream wall should have a top-of-wall elevation of about 74 feet (based on assumed datum, see Figure 2) and the downstream wall about 70 feet. The wall height will vary along the length of each wall, but should be about 3 gabions high at the stream centerline of the upstream wall and 2 gabions high at the centerline of the downstream wall. Gabion walls should not be constructed more than 3 stacks high (9 feet) unless additional blocks are provided at the base for added stability.

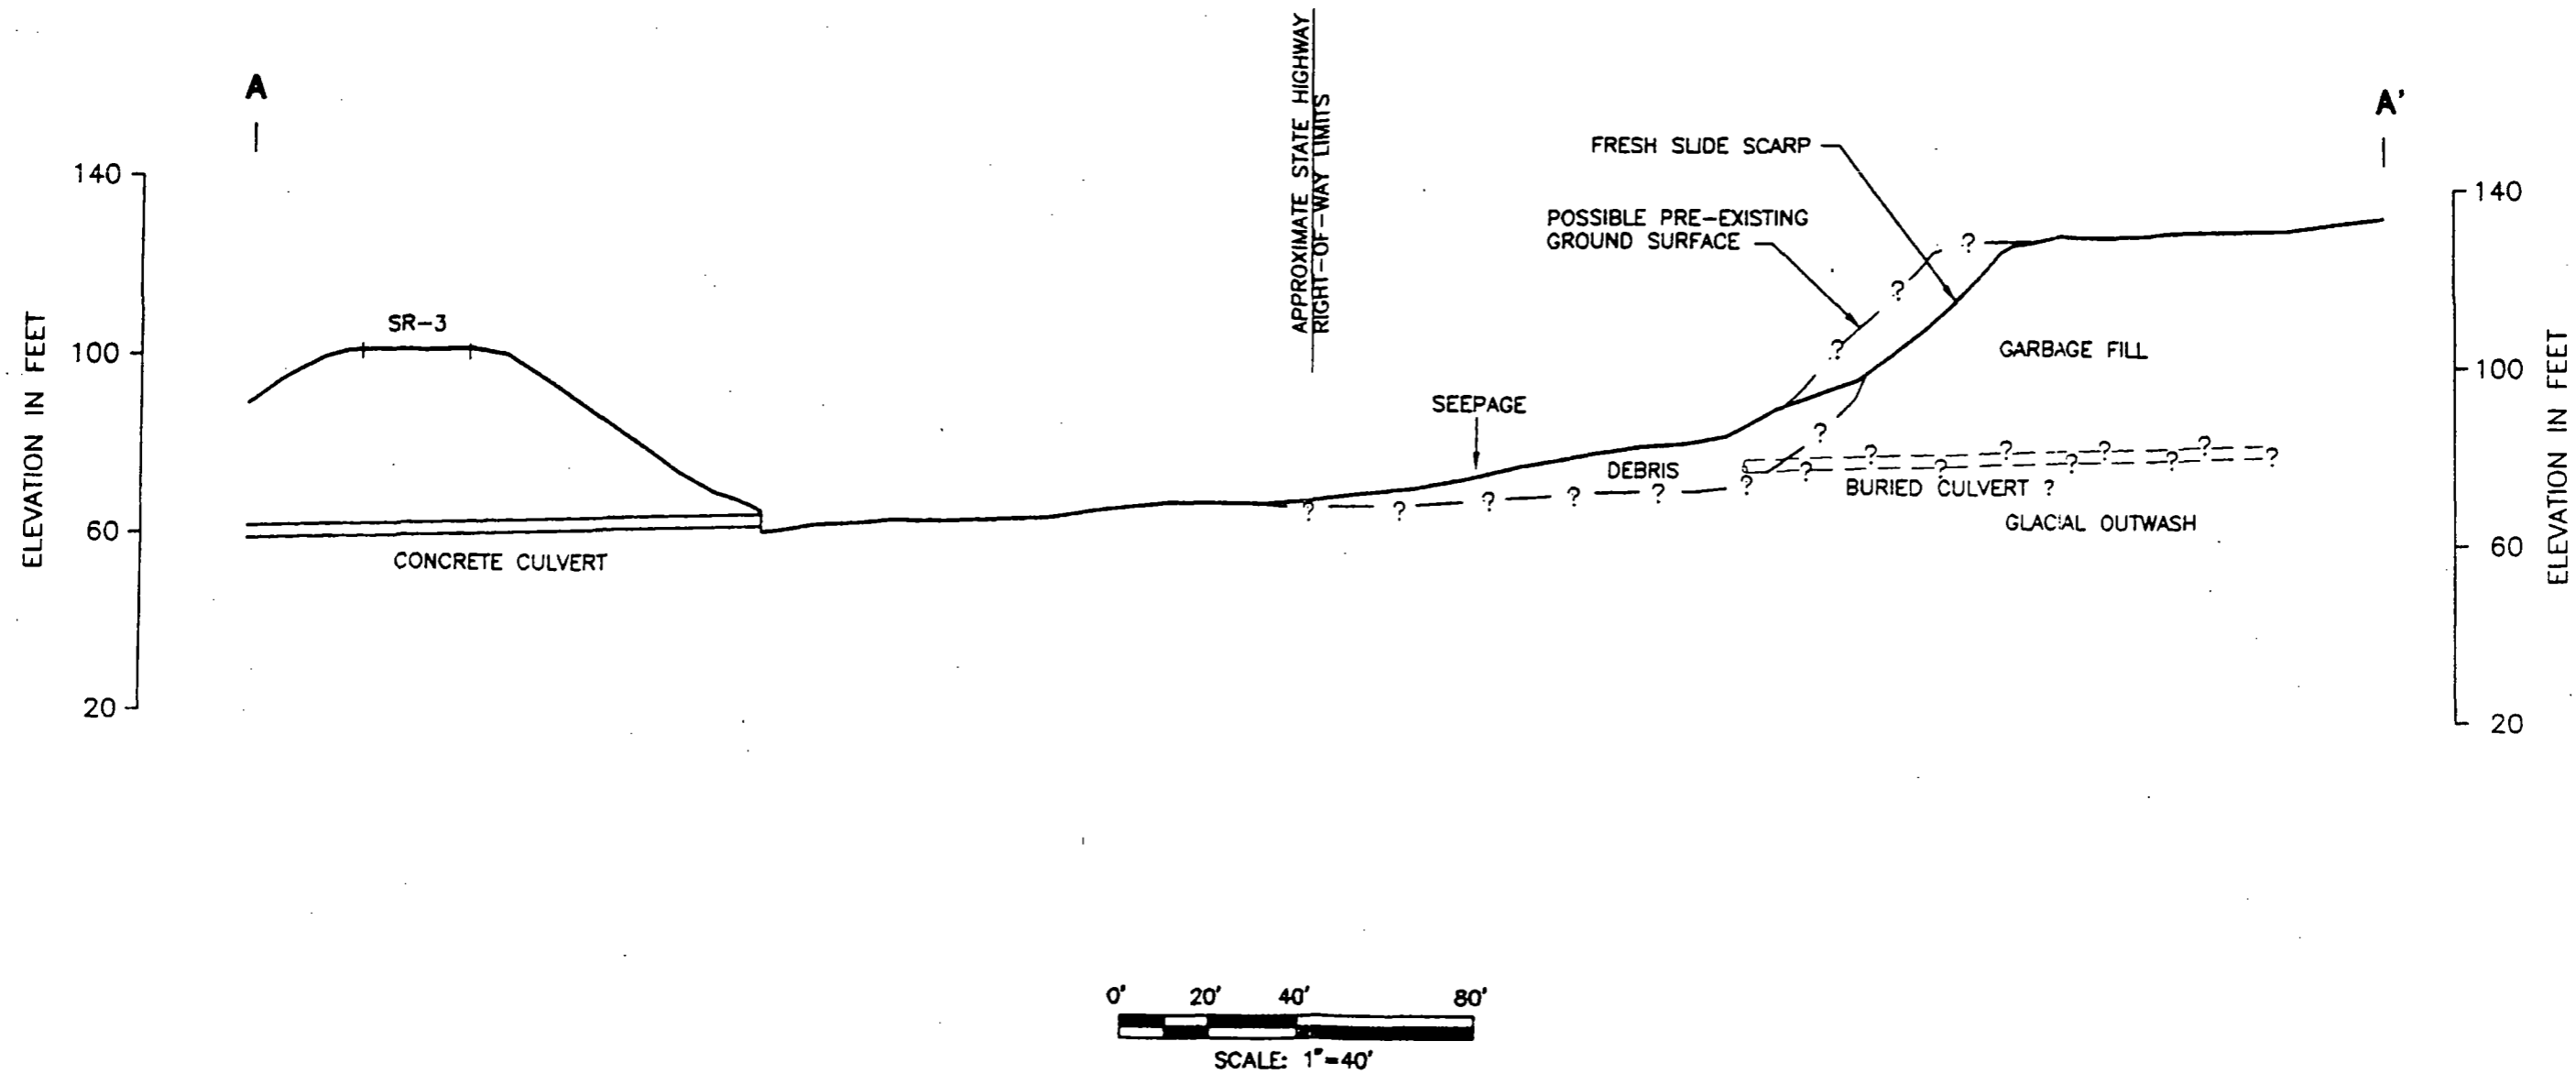
GENERALIZED
PROFILE A-A'

Results of our reconnaissance indicate that native soils at the toe of the slope likely consist predominantly of glacial outwash sands and gravels. On the higher slopes towards the outer edge of the failure, thinly bedded, dense silts and fine sands were noted.
